NASA Technical Memorandum TM 107554

Debris/Ice/TPS Assessment And Integrated Photographic Analysis For Shuttle Mission STS-52

December 1992

Gregory N. Katnik
NASA/Kennedy Space Center

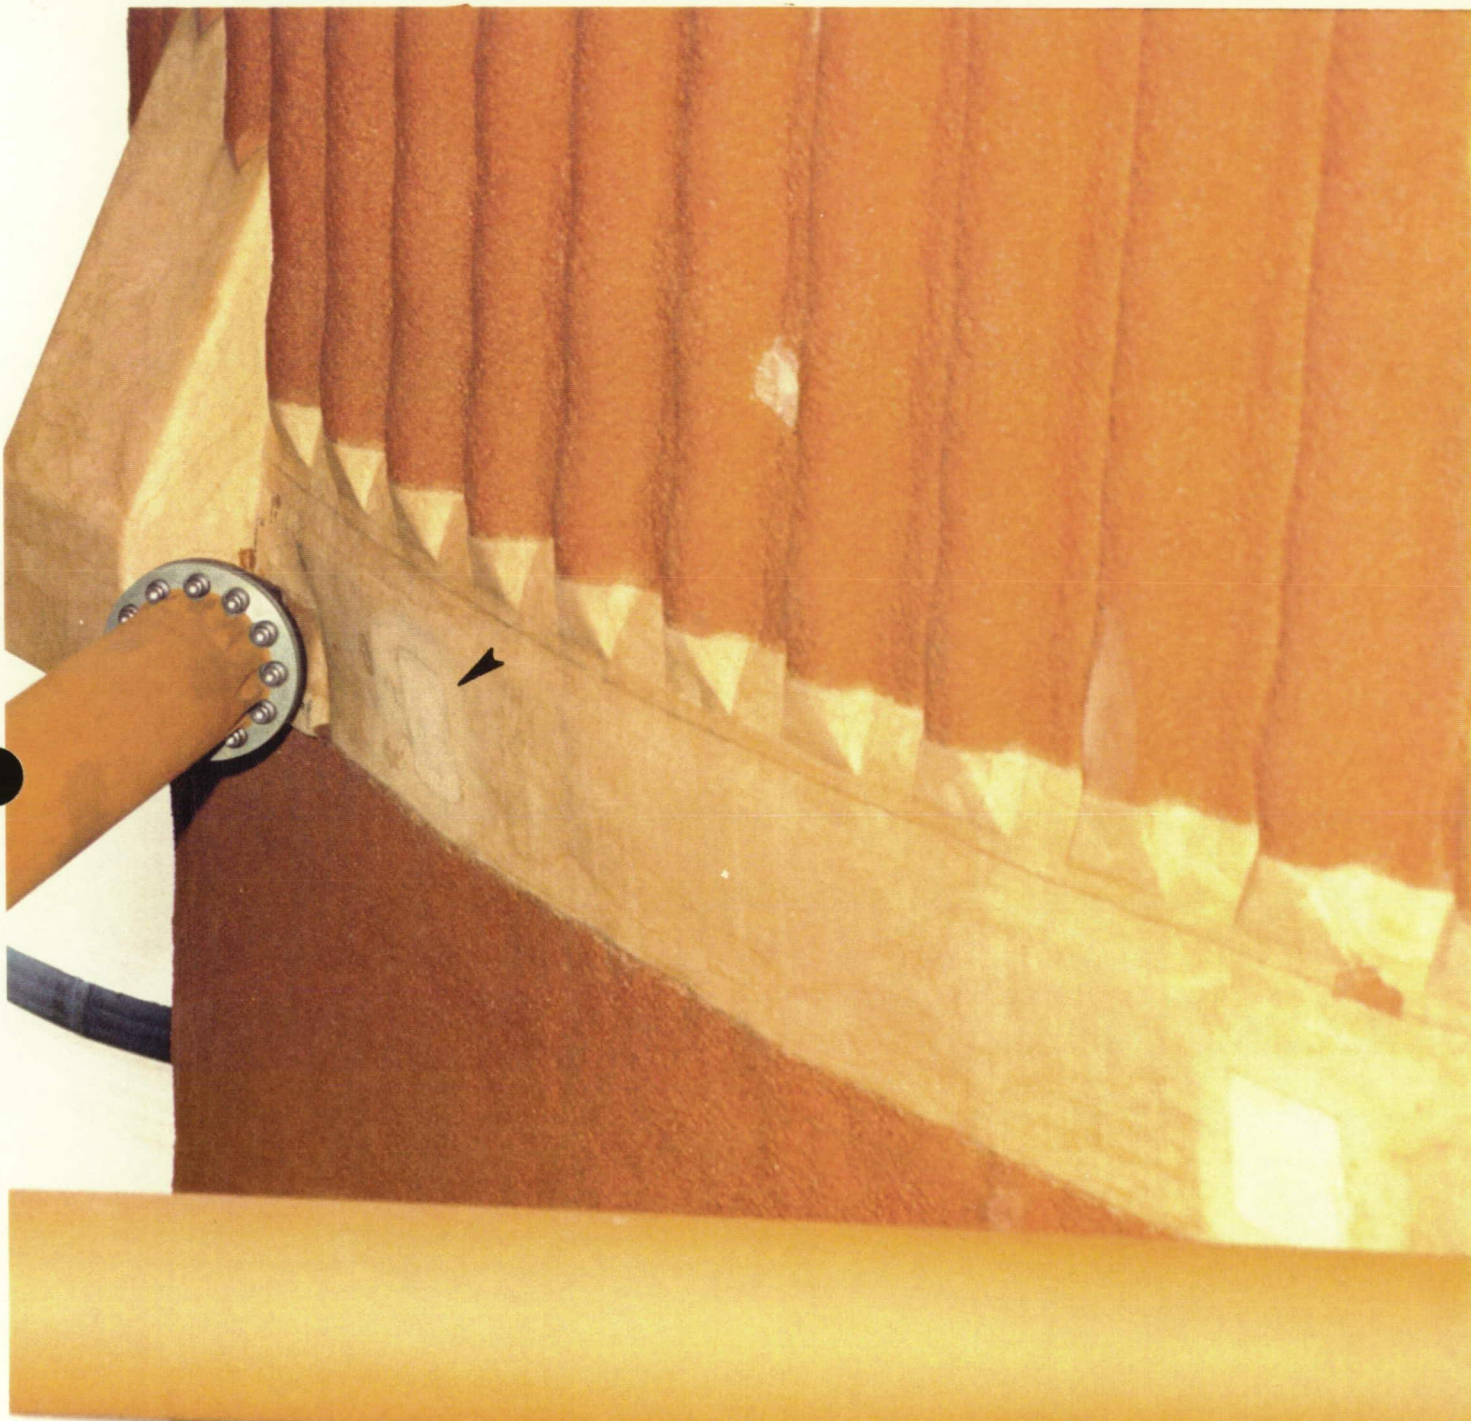
Pre-flight configuration of the bipod jack pad closeouts, the intertank TPS acreage, and the LH2 tank flange closeout. Post ET separation photography would reveal the loss of TPS from the intertank acreage and the LH bipod jack pad closeout.

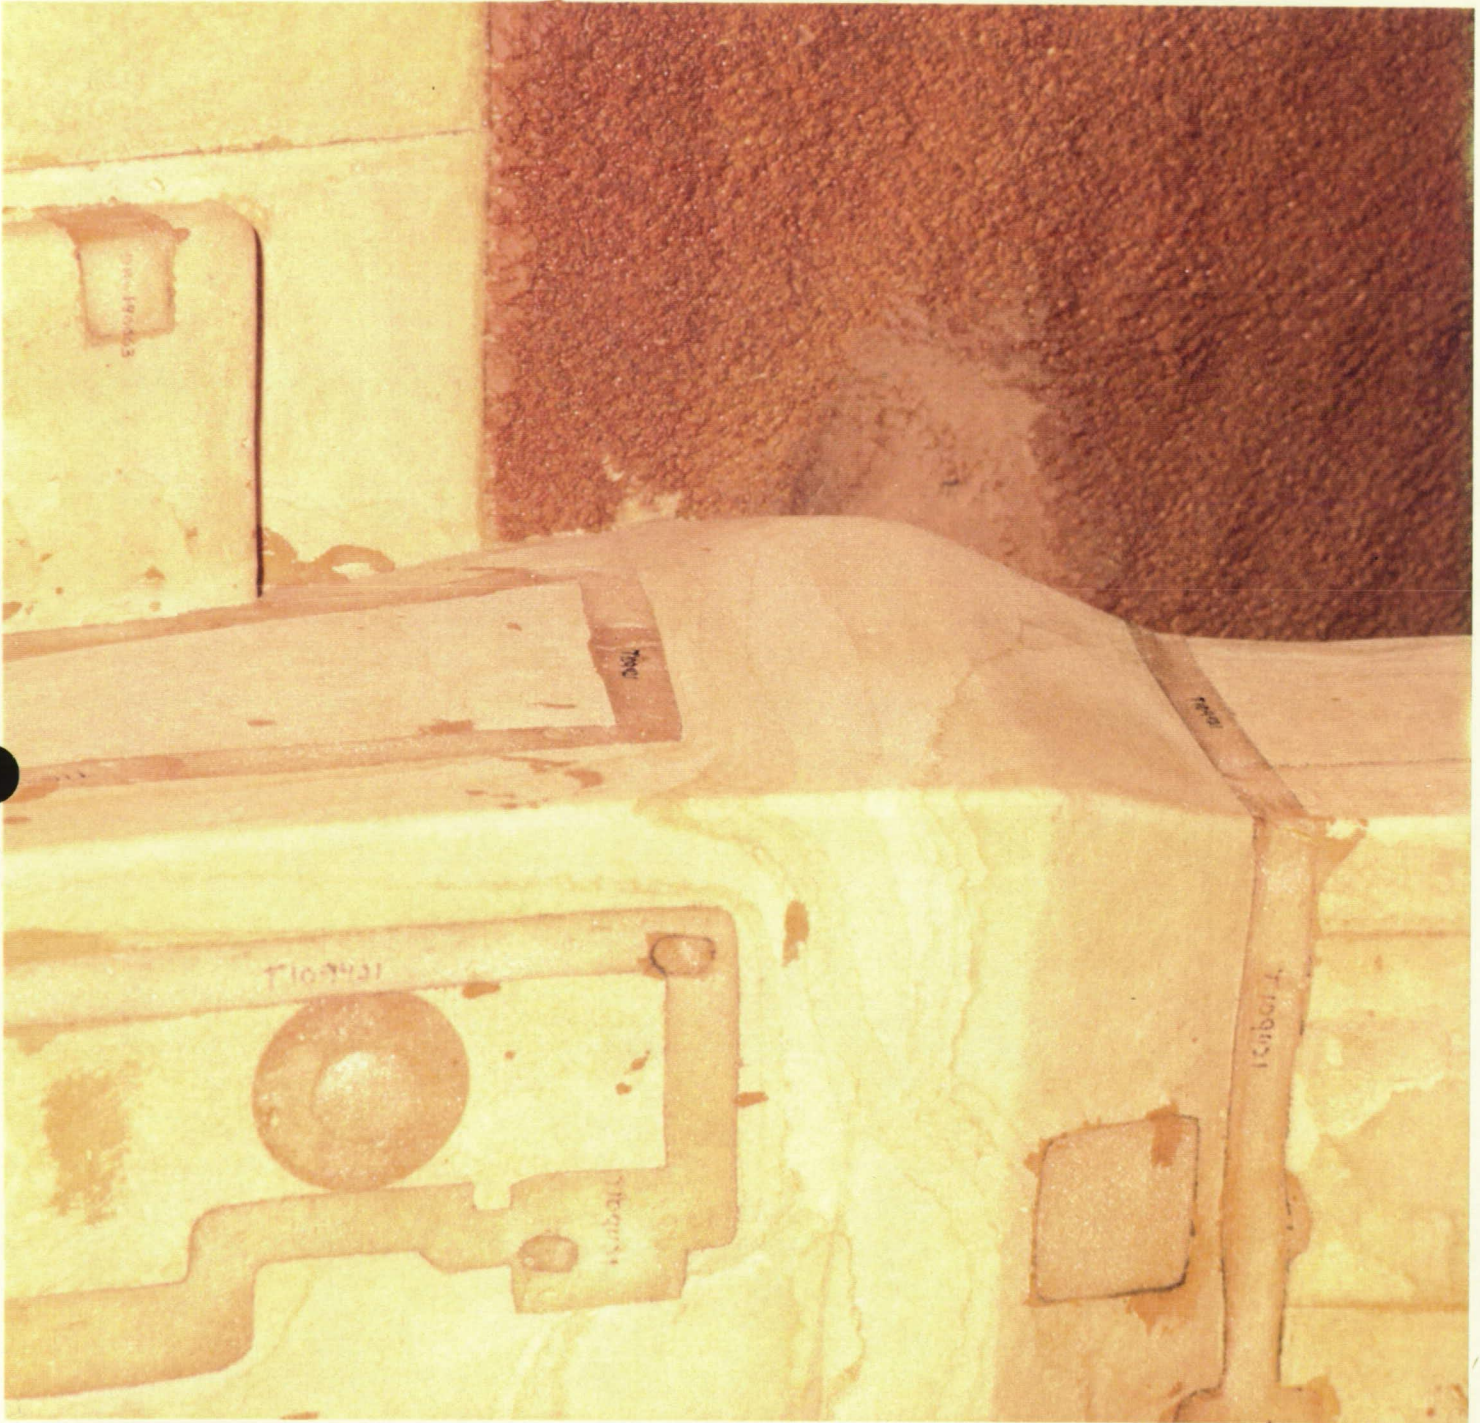
LH (-Y) vertical strut/cable tray TPS covering prior to cryogenic fuel loading. Cracks have appeared in this general area after cryoload due to the elimination of a stress relief gap as part of a manufacturing process enhancement change.

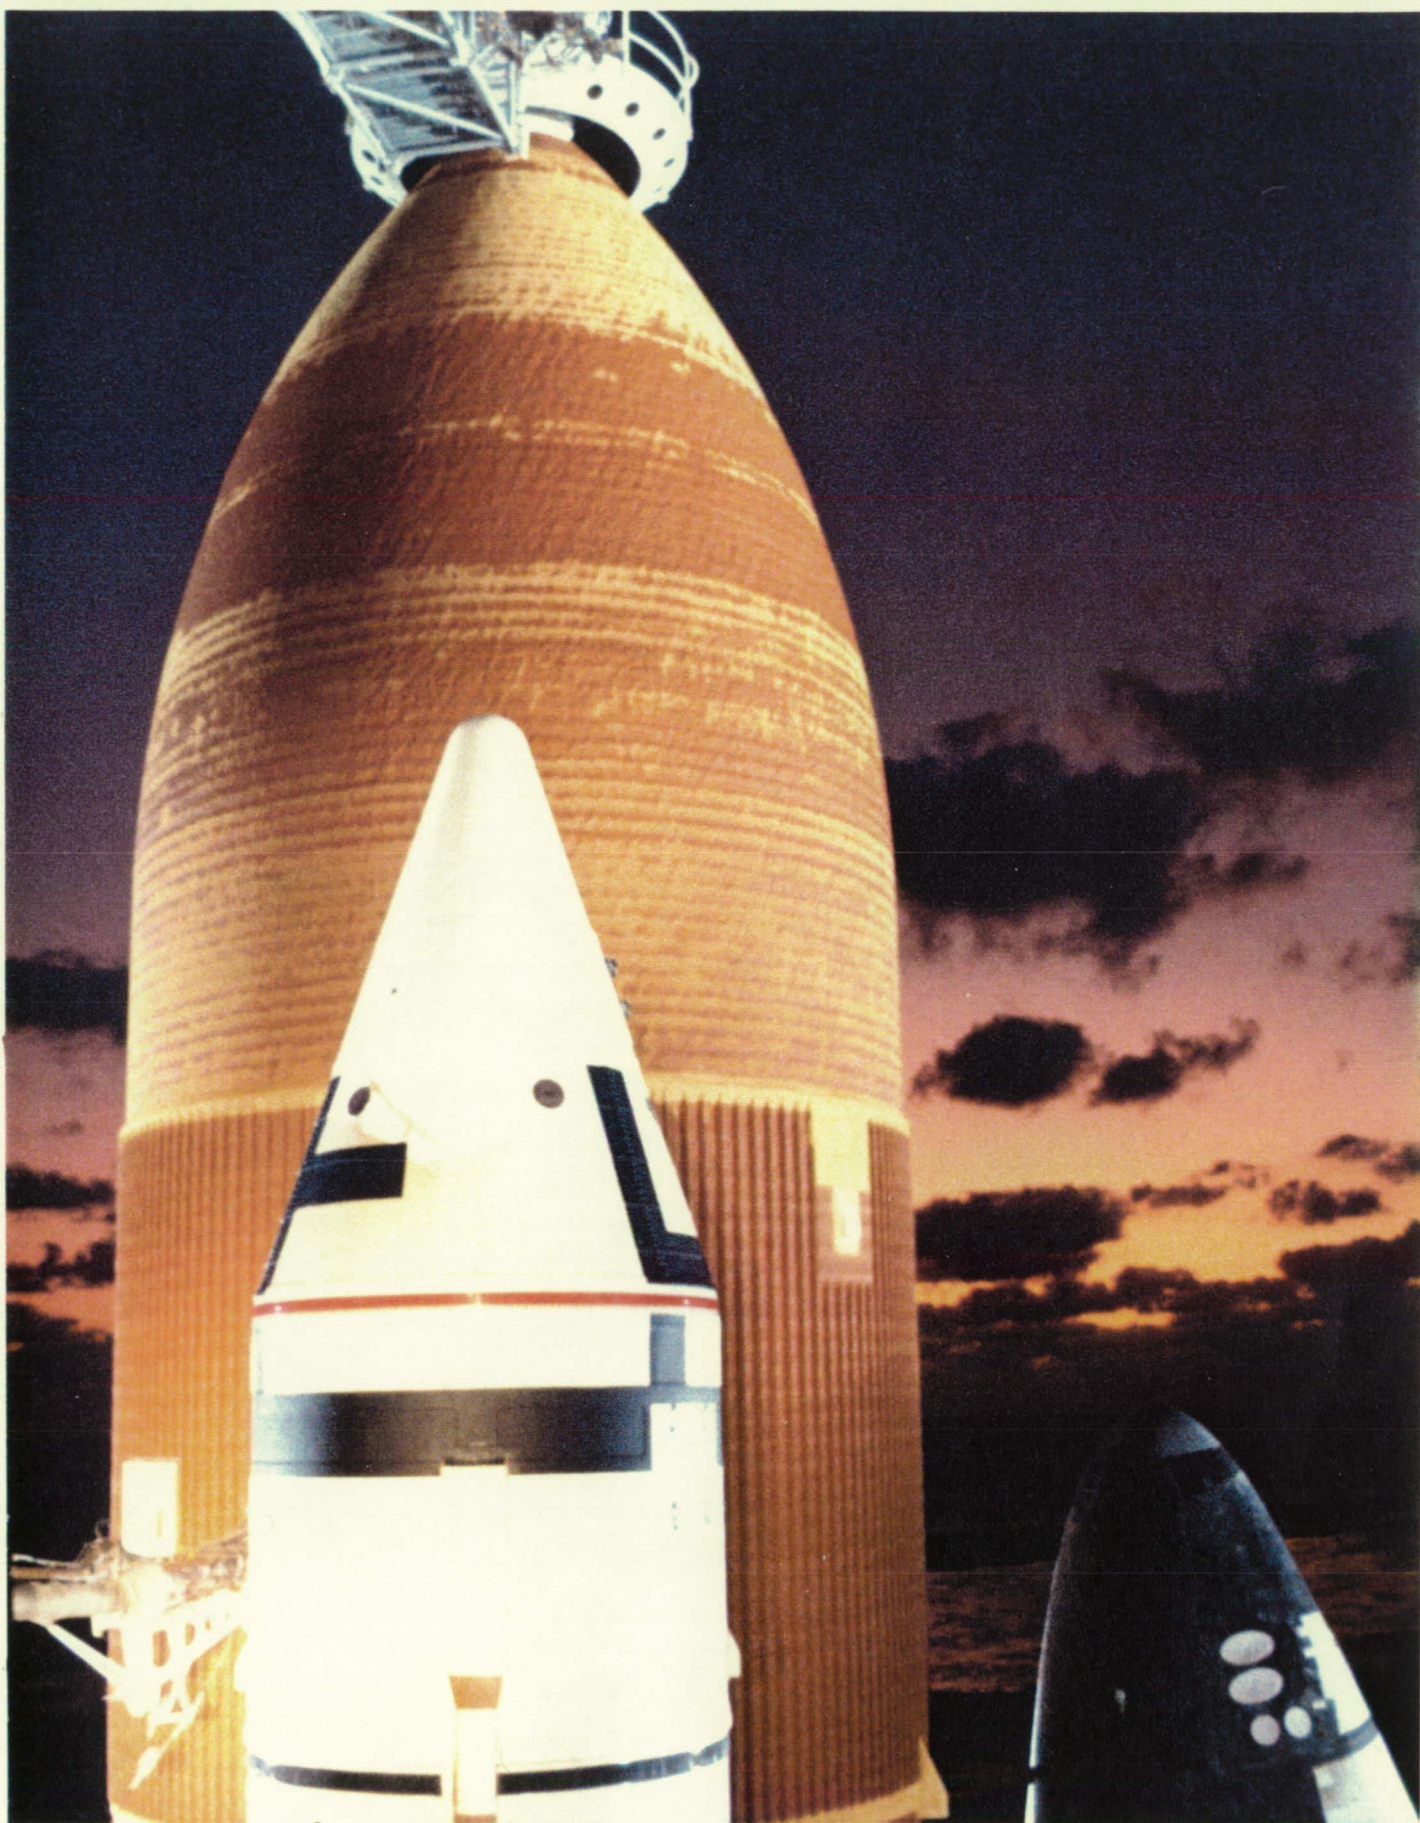
No condensate, ice, or frost accumulation was present on the
ET LO2 tank and intertank TPS acreage

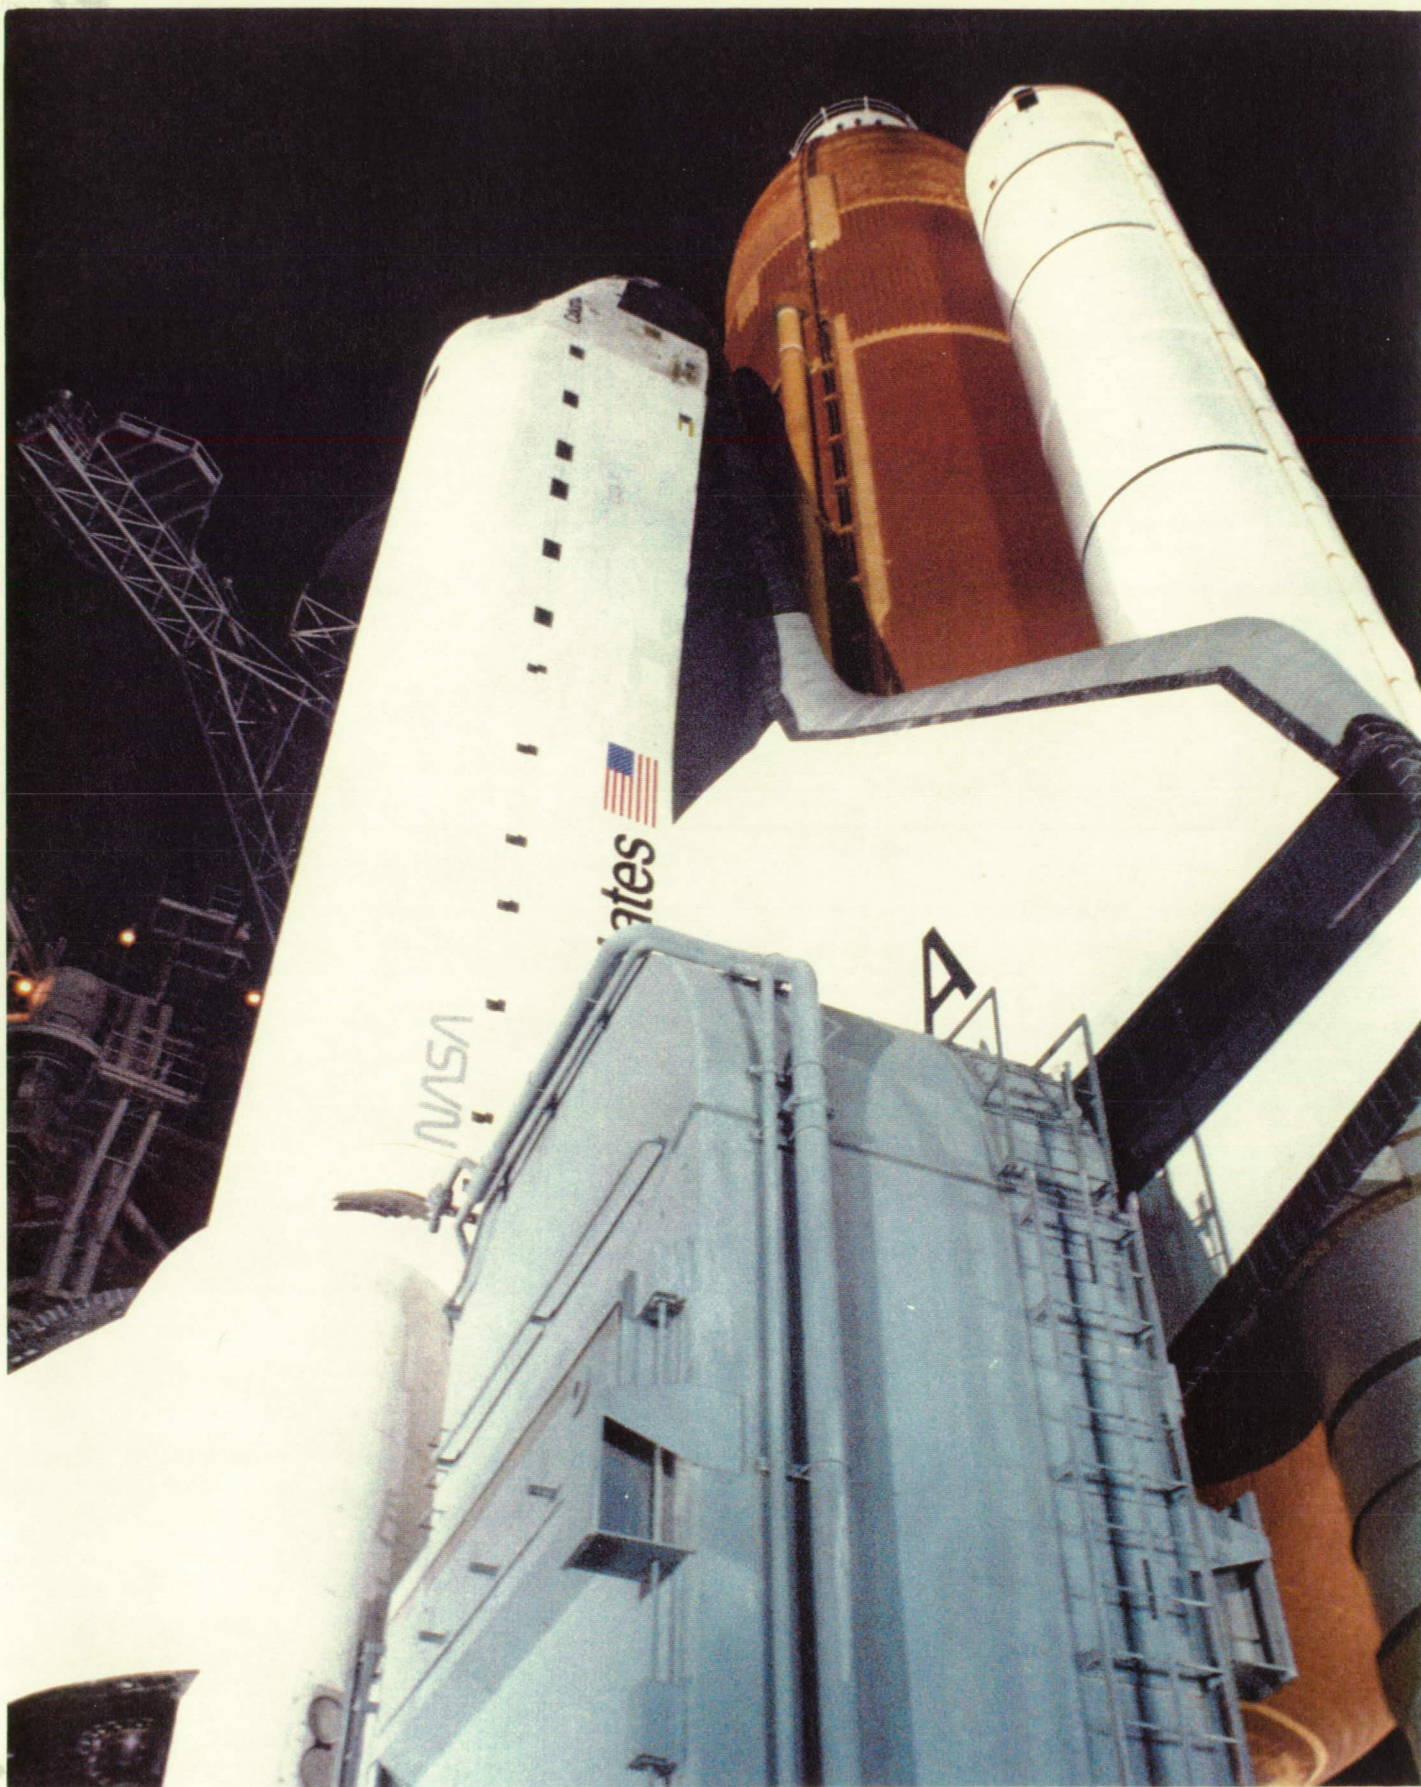
Light condensate, but no ice or frost accumulation, was present on the LH2 tank acreage and aft dome

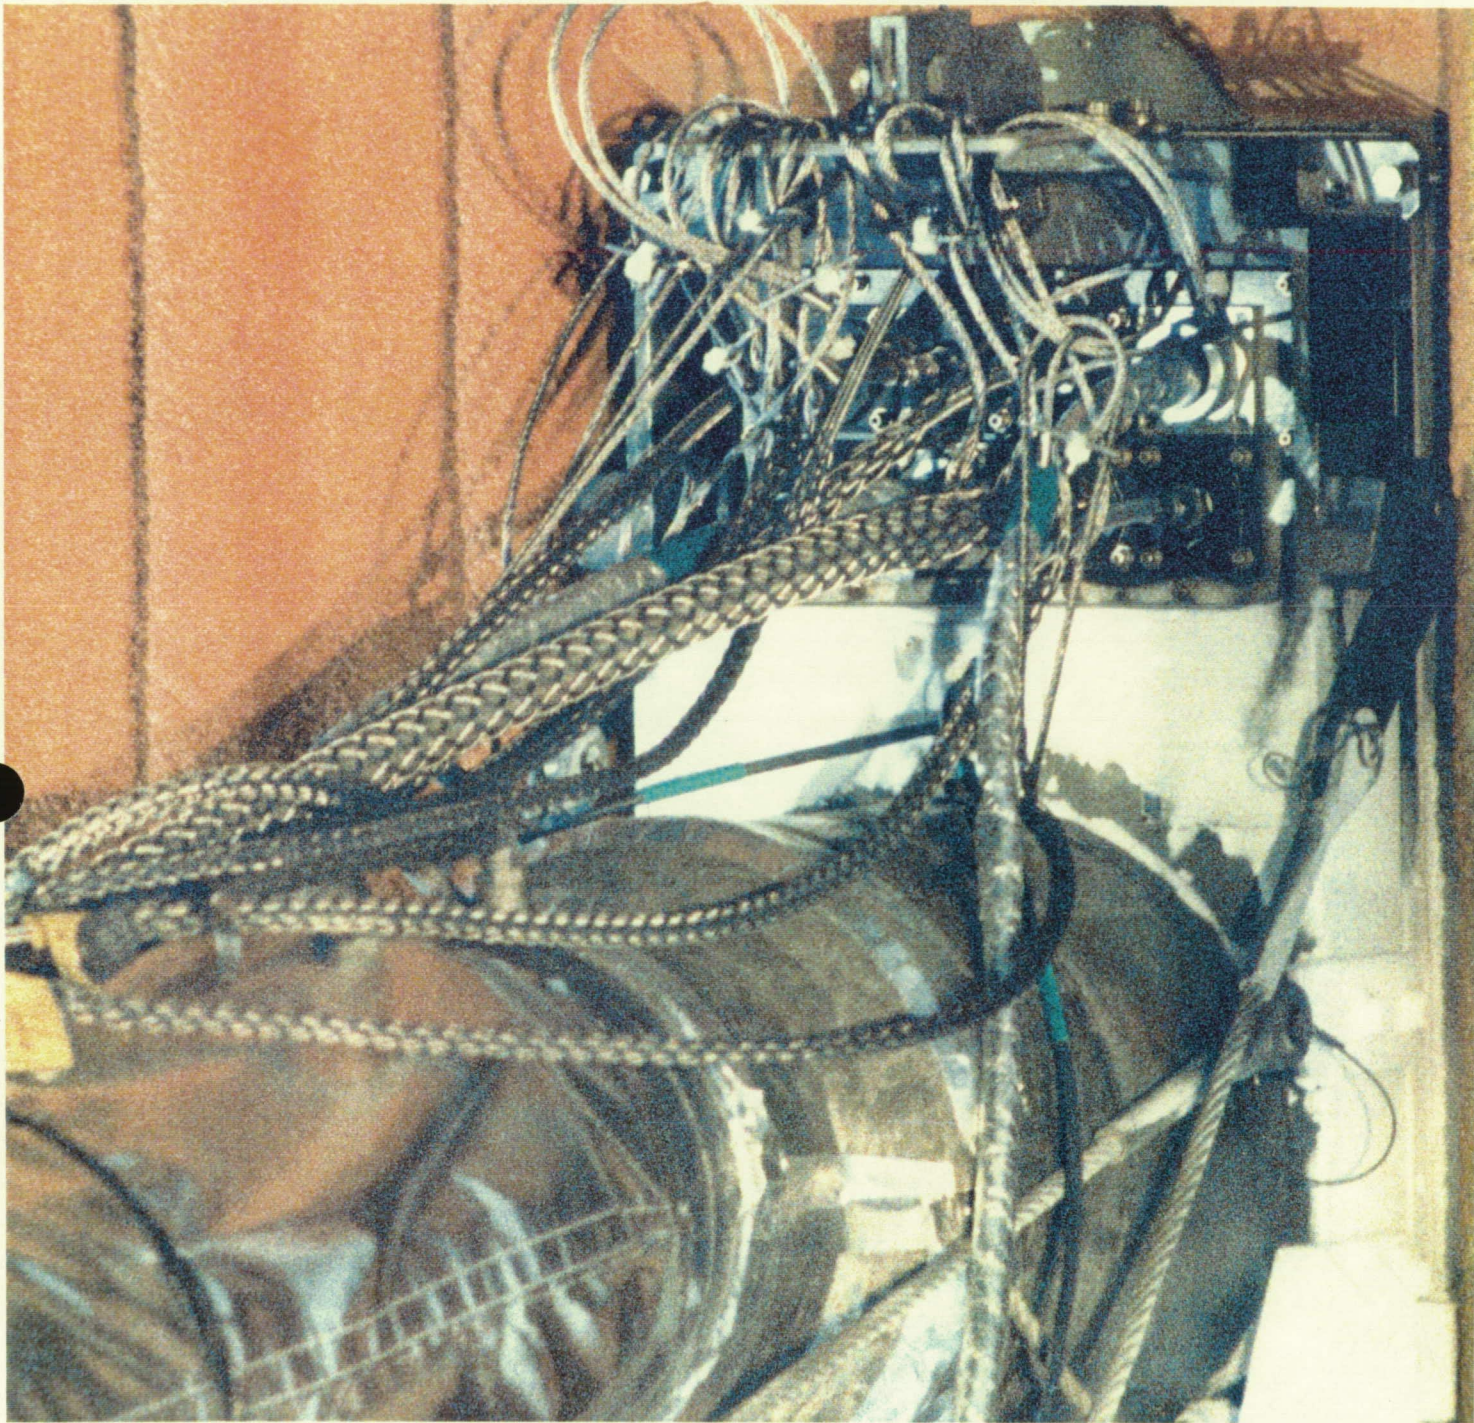
Leak detectors #23 and #25 located within the GUCP cavity indicated the presence of a hydrogen leak external to the vent line from cryogenic loading slow fill through stable replenish. Readings peaked during vent valve open cycles. The leak reached a maximum value of 44,000 ppm thirty minutes into topping then remained at 20-30,000 ppm during replenish. The suspected area of leakage was at the tank side teflon seal, which mates with the 7-inch GH2 vent quick disconnect probe. More than usual amounts of ice and frost covered the uninsulated areas of the GUCP around the 7-inch line. Post launch inspection and retest of the GSE hardware did not reveal any anomalies.

A hydrogen leak external to the vent line occurred from cryogenic loading slow fill through stable replenish. More than usual amounts of ice and frost covered the uninsulated areas of the GUCP around the 7-inch line. Post launch inspection and retest of the GSE hardware did not reveal any anomalies.

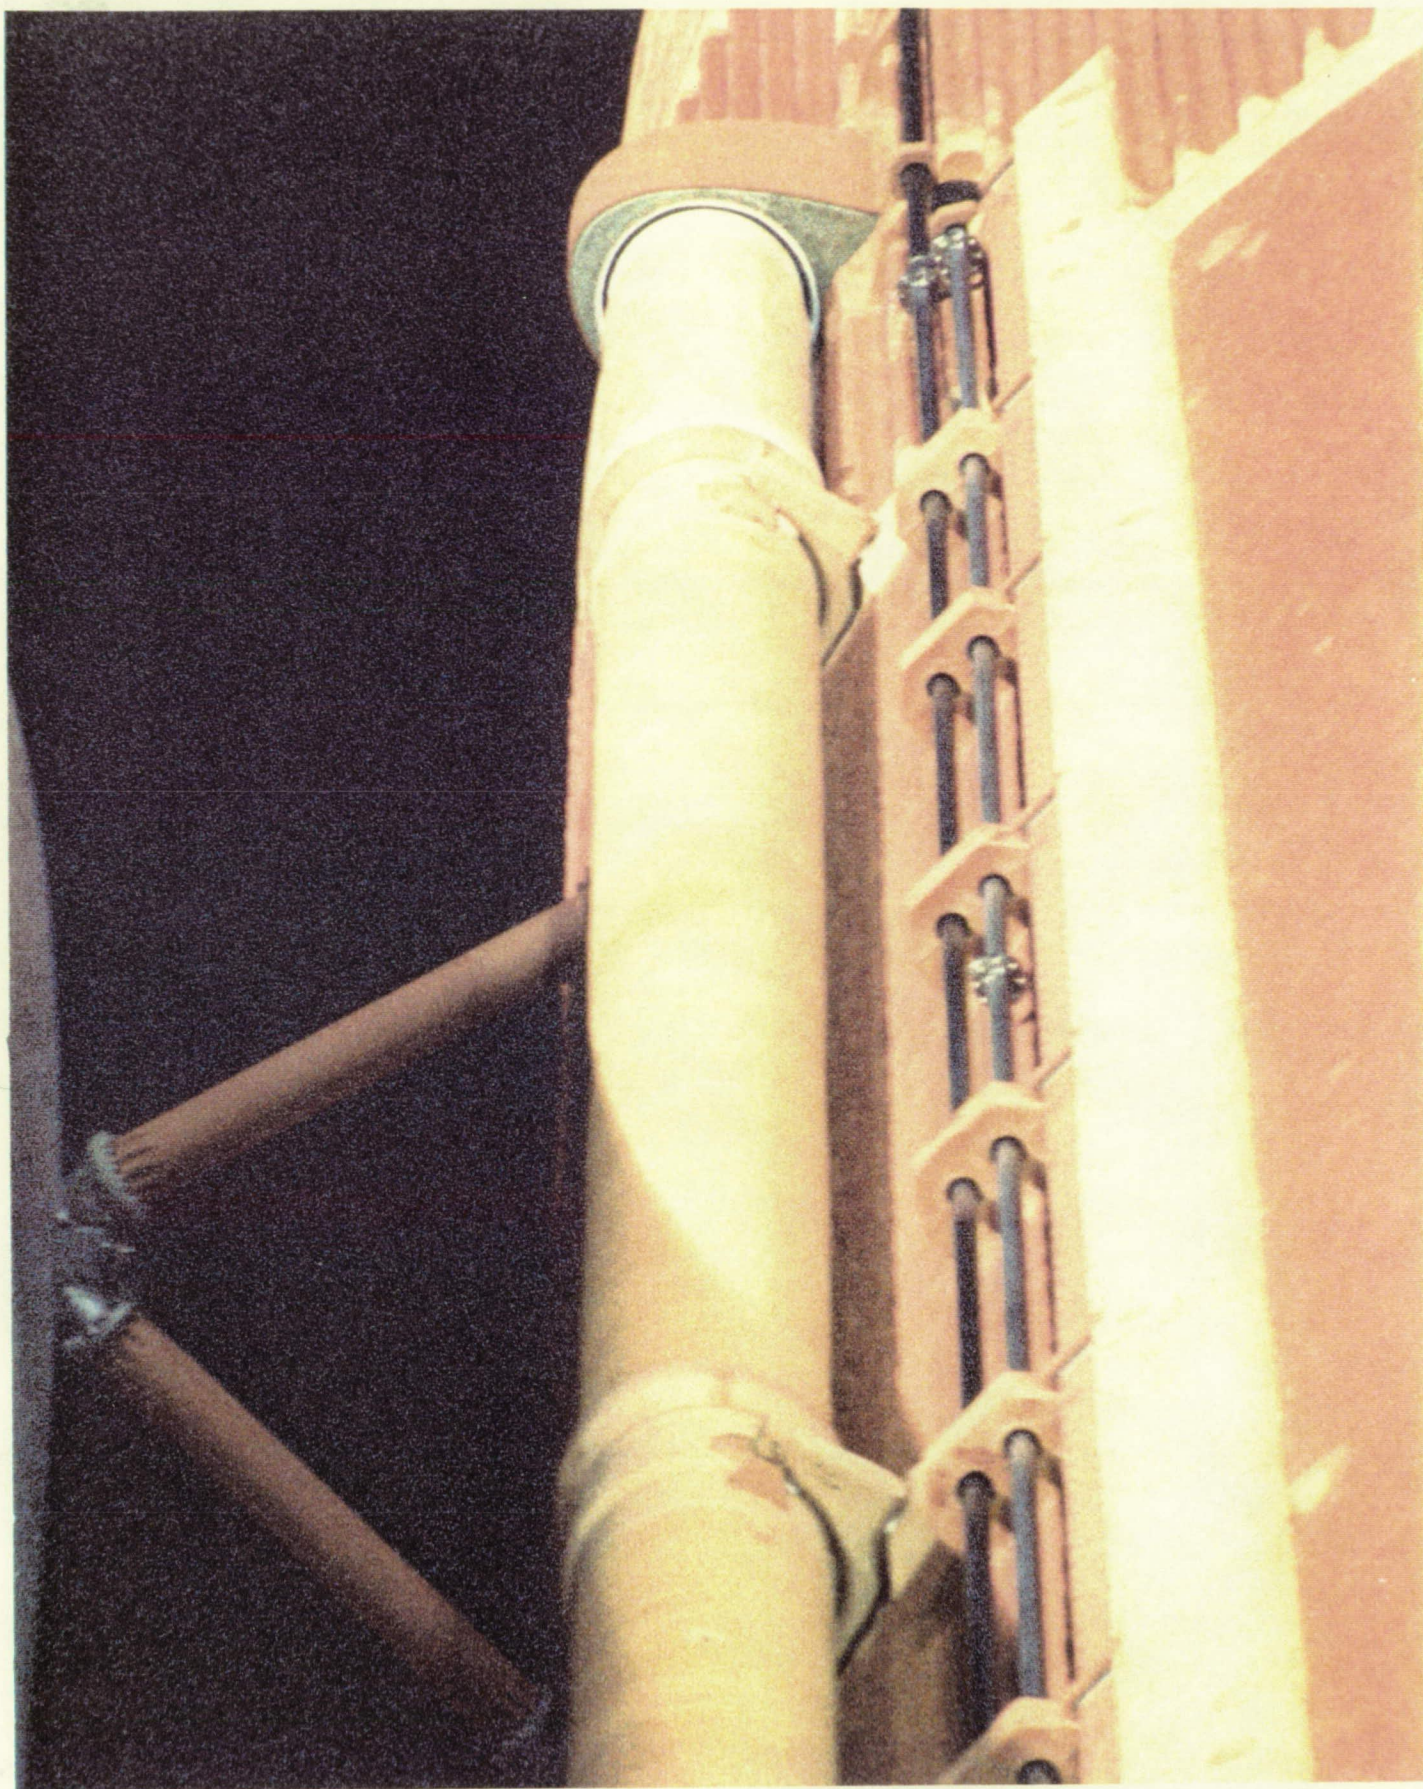
Typical amounts of ice/frost had formed in the L2 feedline support bracket and upper bellows

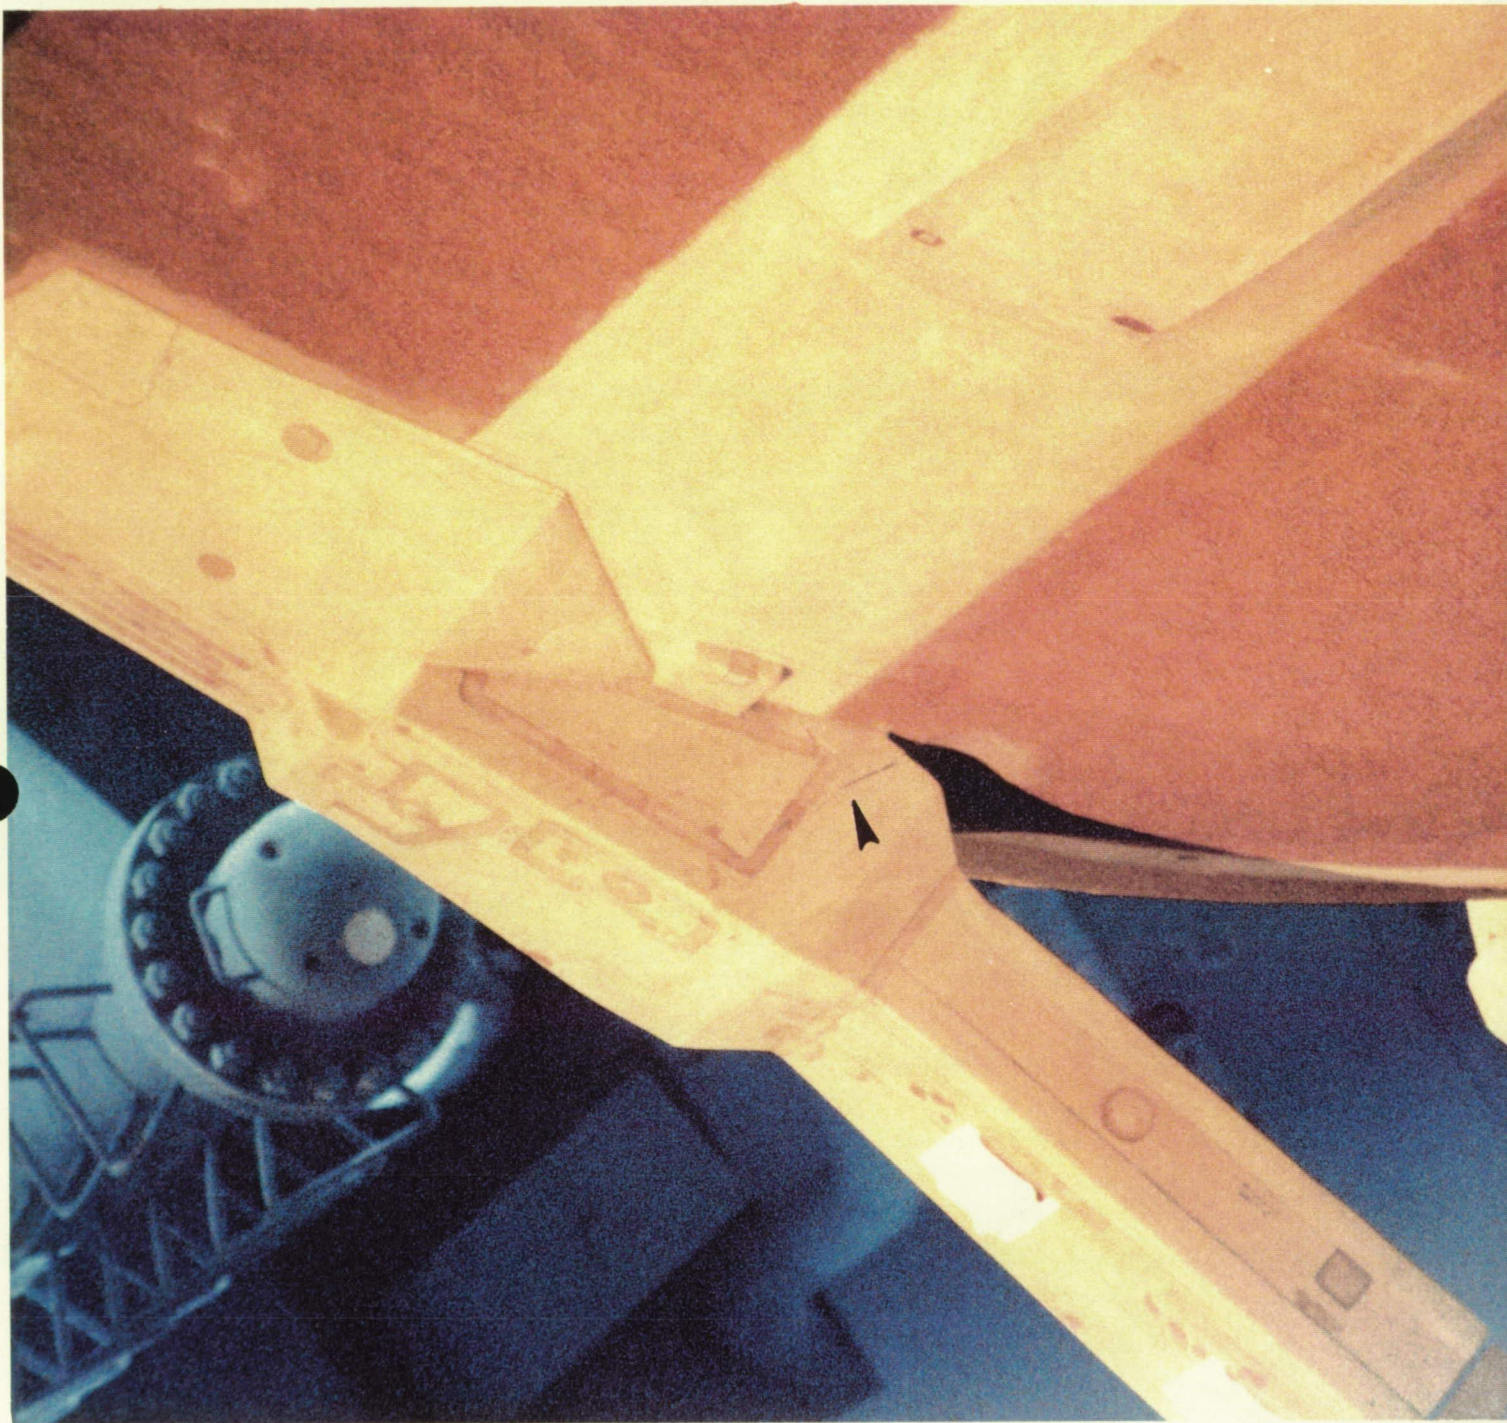
An 8-inch long dogleg crack was present in the forward surface TPS covering of the -Y vertical strut cable tray near the longeron closeout interface. The 3/8-inch wide crack exhibited no offset and was not filled with ice or frost. The appearance of the crack was expected due to the elimination of the stress relief gap at the factory.

Anomaly 003 documented an 8-inch dogleg crack in the forward surface TPS covering of the -Y vertical strut cable tray at the intersection to the ET/SRB cable tray transition fairing. The 3/8-inch wide crack exhibited no offset and was not filled with ice or frost. The condition was acceptable for launch per NSTS-08303 and CR S041254C.

An 8-inch long dogleg crack appeared in the LH (-Y) vertical strut/cable tray forward facing TPS covering near the longeron closeout interface. A stress relief cut in the TPS to allow for structural movement had been deleted by design. This condition was acceptable for flight per the NSTS-08303 criteria

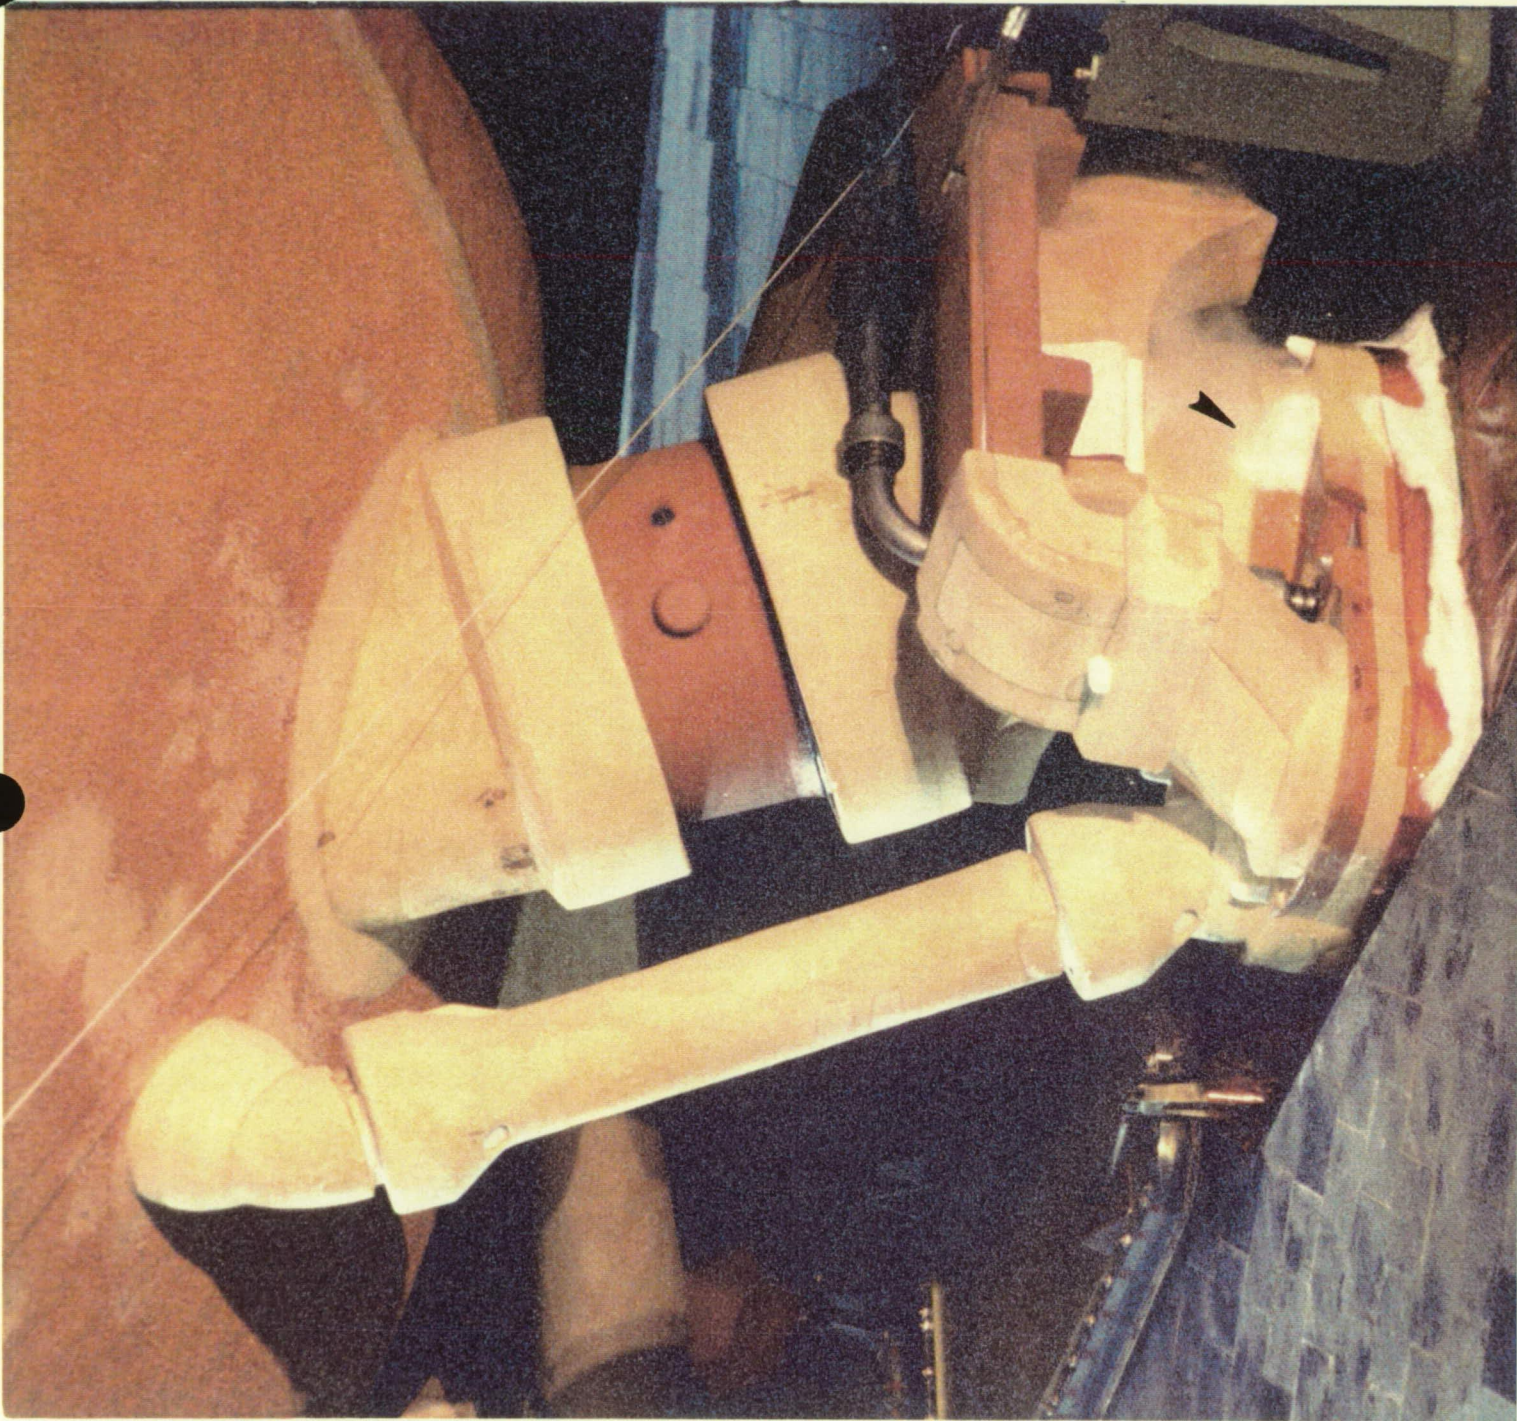
Typical amounts of ice/frost had formed on the top and outboard sides of the LH2 ET/ORB umbilical/purge barrier. Normal amounts of ice had accumulated on the plate gap and pyrotechnic canister purge vents, and the LH2 recirculation line bellows. Ice was present on the forward outboard pyrotechnic canister closeout bondline indicating a thermal short (arrow).

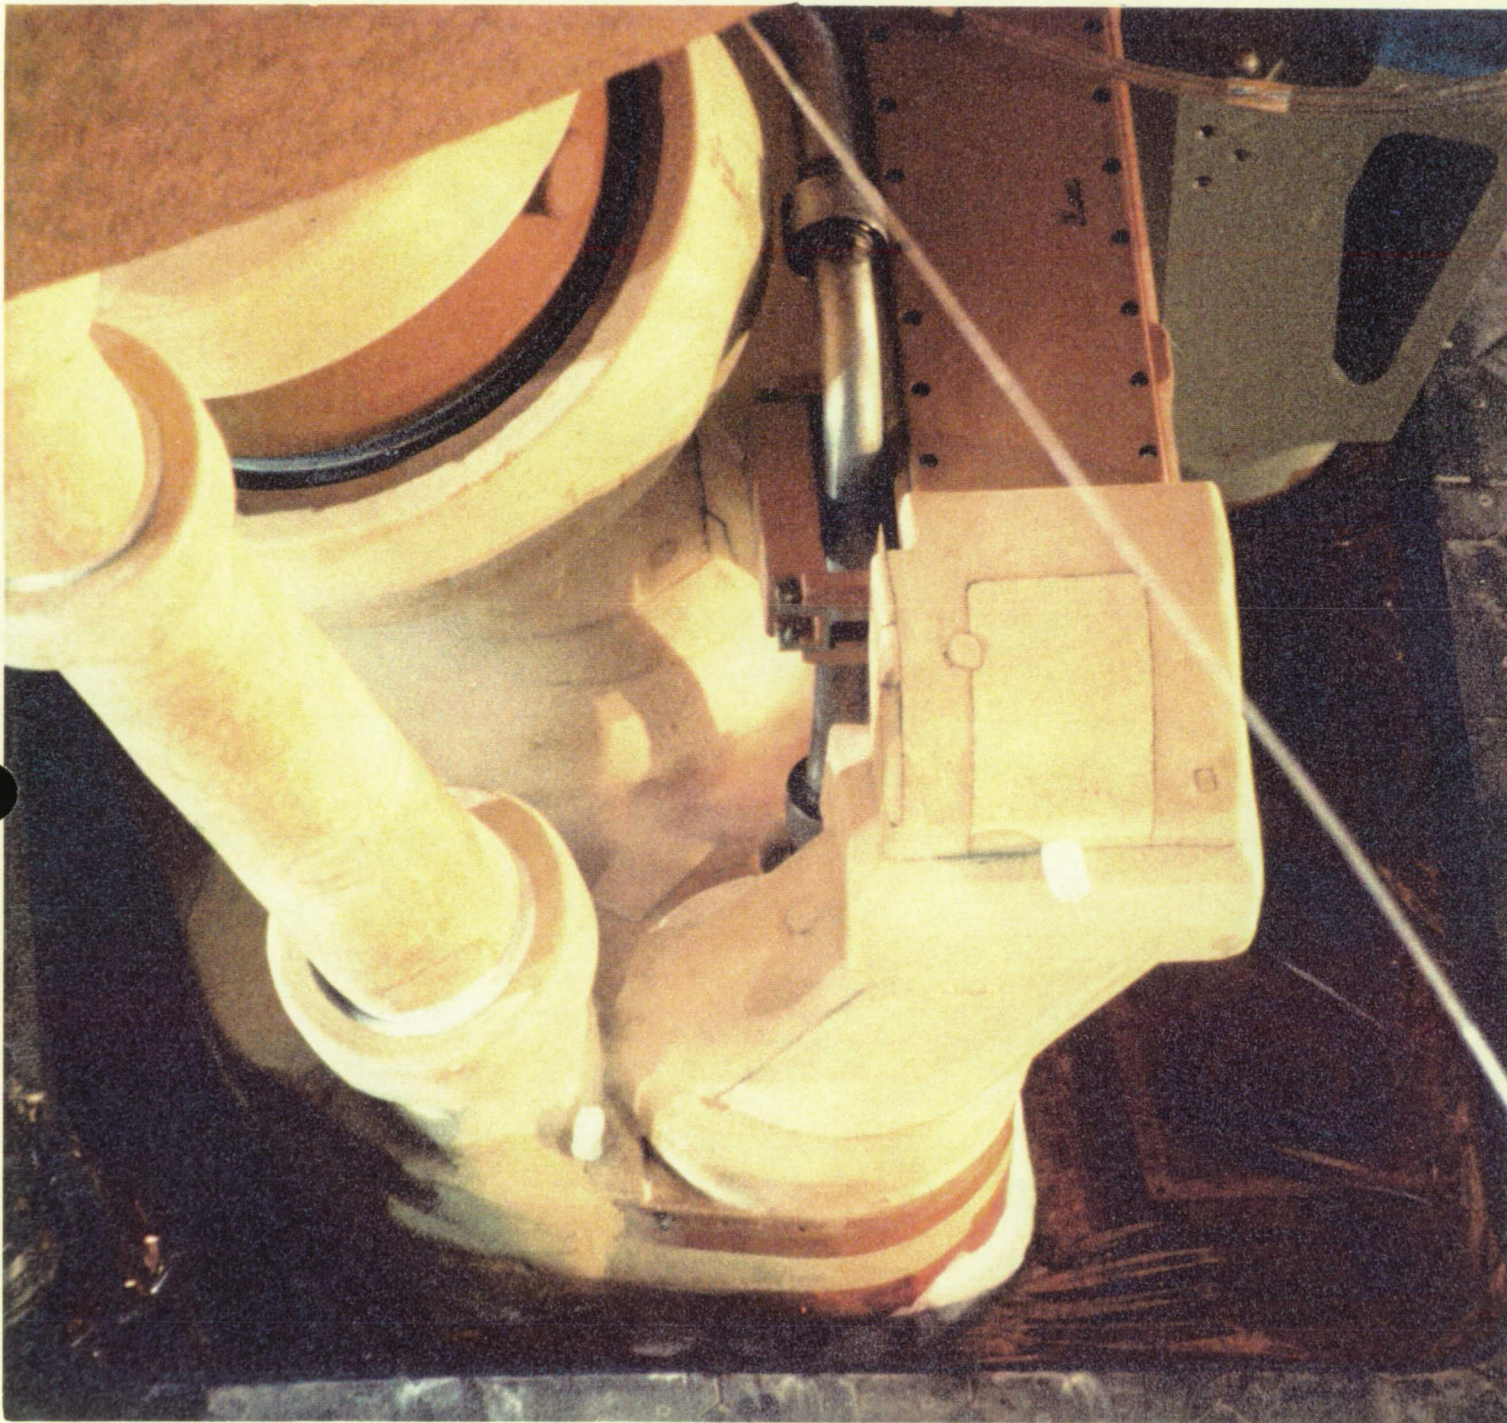
Typical in size, ice/frost fingers had formed on the aft plate gap purge vent and LH2 umbilical cable tray vent hole. The lack of ice or frost on the 17-inch flapper valve actuator access port foam plug closeout indicated a tight seal and nominal closeout.
